# Seathwaite Tarn Reservoir

## repairs to a remote reservoir in Cumbria

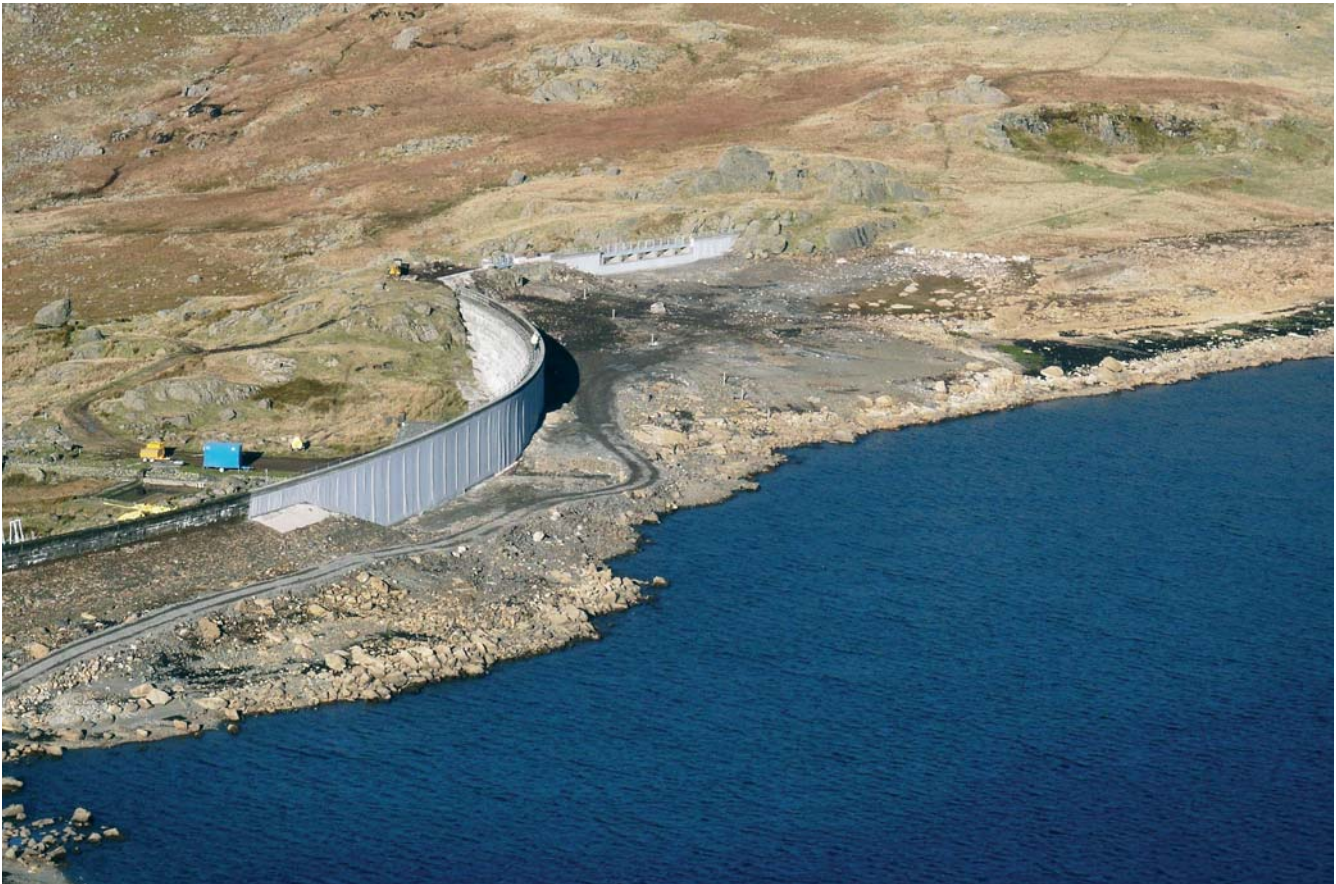
*Aerial view, upstream face of concrete dam and auxiliary overflow showing temporary access and Carpi Membrane Courtesy of Eric Wright Civil Engineering Ltd and MWH*

The remedial works on the upstream face included the installation of a PVC geocomposite membrane, geonet drainage layer and associated drainage system to the upstream face of the main dam and the auxiliary overflow. The geomembrane is sealed on the concrete face along the foundation line and on the parapet wall 300 mm above the crest level to cover the joint between the upstream face and the parapet wall. The geomembrane covers a total surface area of 1,100m<sup>2</sup>.

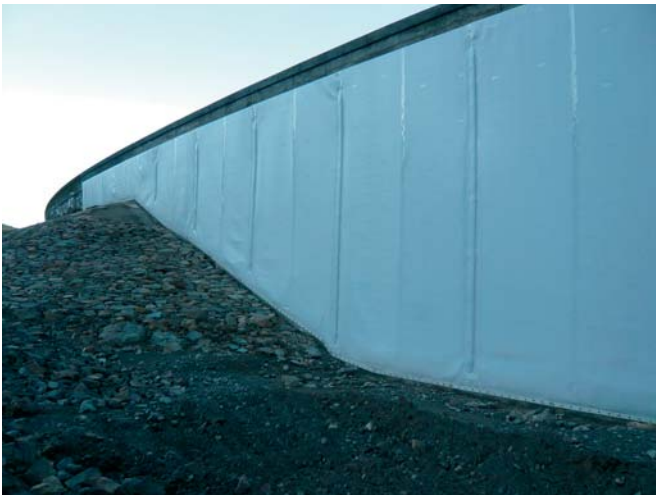
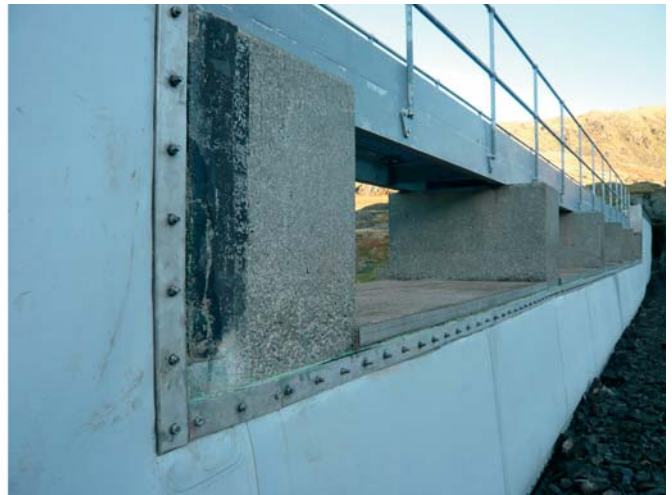
In addition to the poor condition of the downstream face, it was noted that there were numerous significant horizontal and vertical cracks on the upstream face, many filled with calcite. Finally, it was found that the wave wall was also in poor condition and it was noted that it does not reach 'high' ground at the left hand end of the dam.

Photos show new membrane on upstream face of concrete dam (left) and auxiliary overflow (right)

A Geomembrane drainage system was incorporated into the design to discharge water through 3 holes in the dam. Joints and cracks in the concrete were treated with an acrylic resin where the perimeter seal crosses the joint to prevent reservoir water bypassing the perimeter seal.

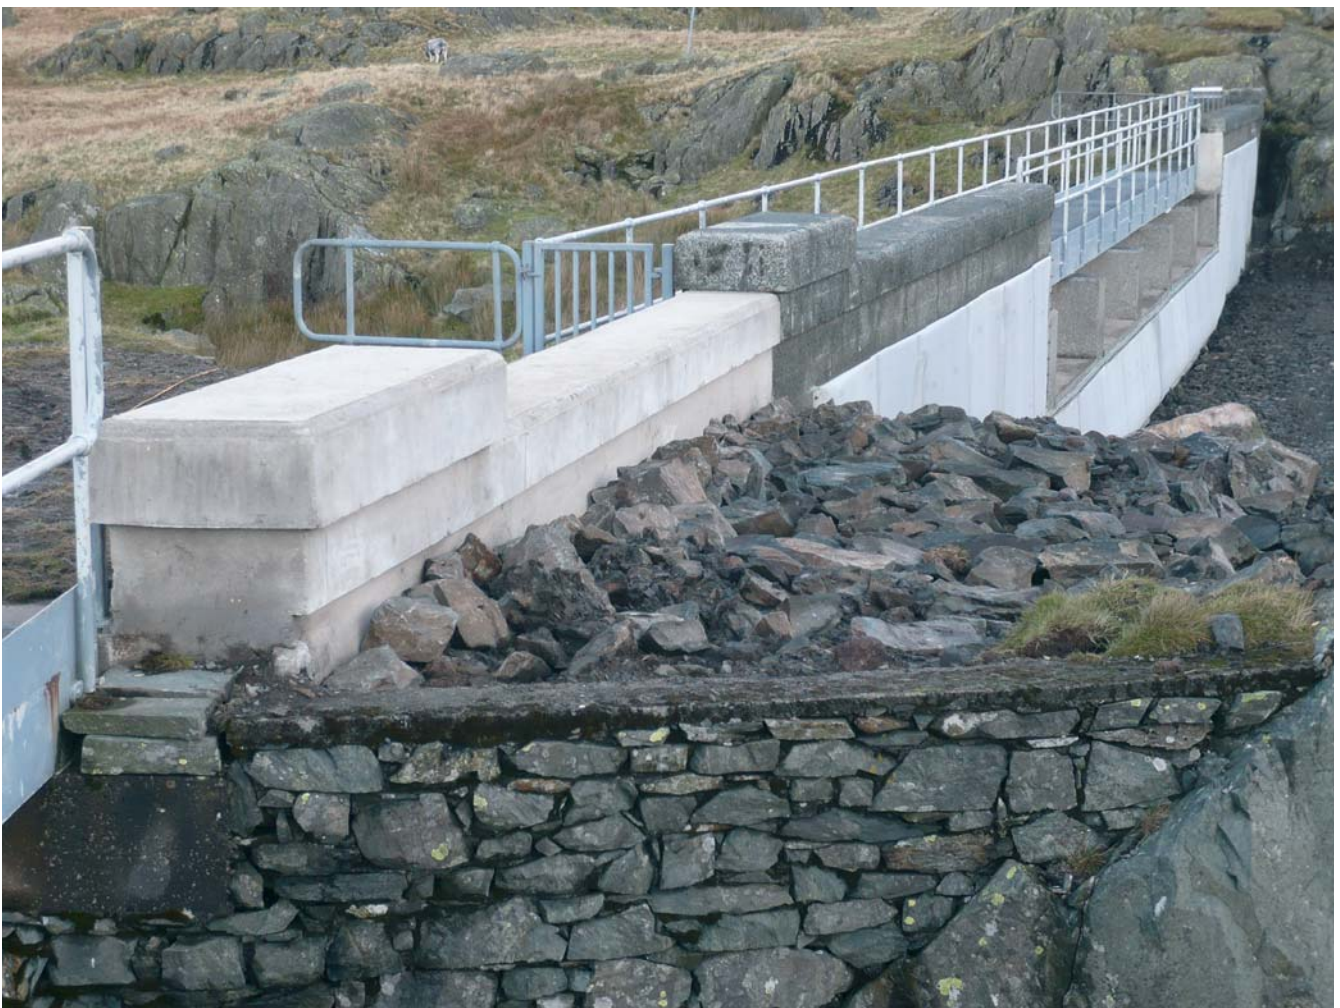
Modifications to auxiliary overflow structure and wave wall extension

A reinforced concrete wave wall was constructed to the same dimensions and levels as the existing but it extended into the high ground at the left and right ends of the dam.

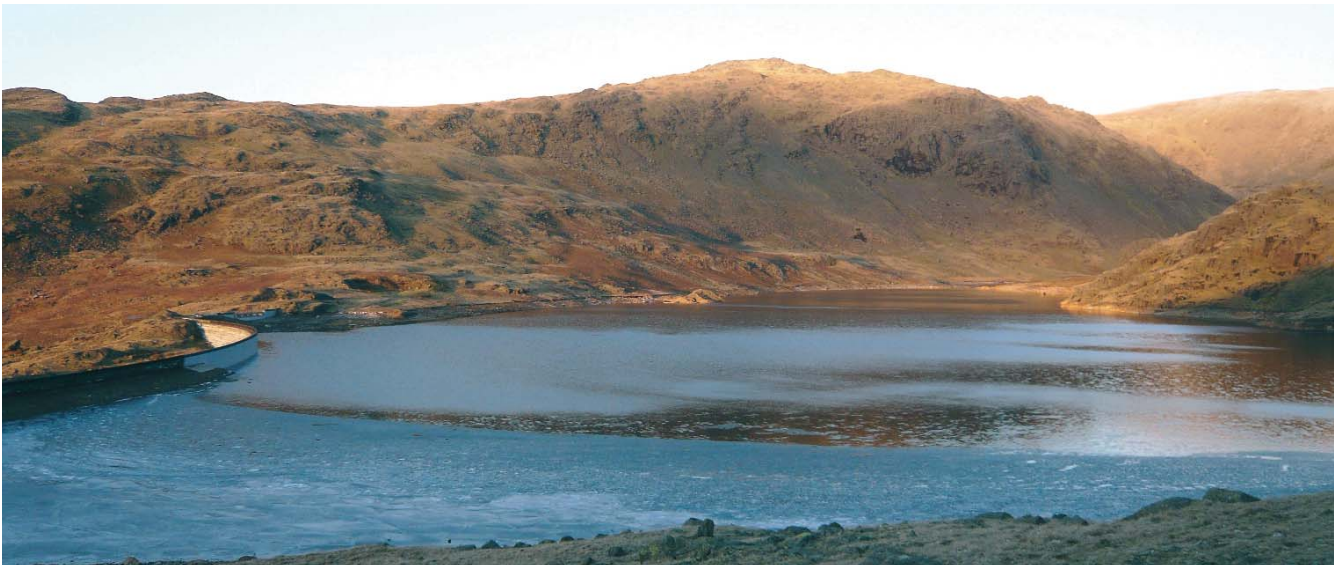
Seathwaite IR after completion of refurbishment
