Scunthorpe, Ashby South Grange UID

two key CSO overflows that had UID's within catchment

by Frank Thompson BEng (Hons), CEg MICE

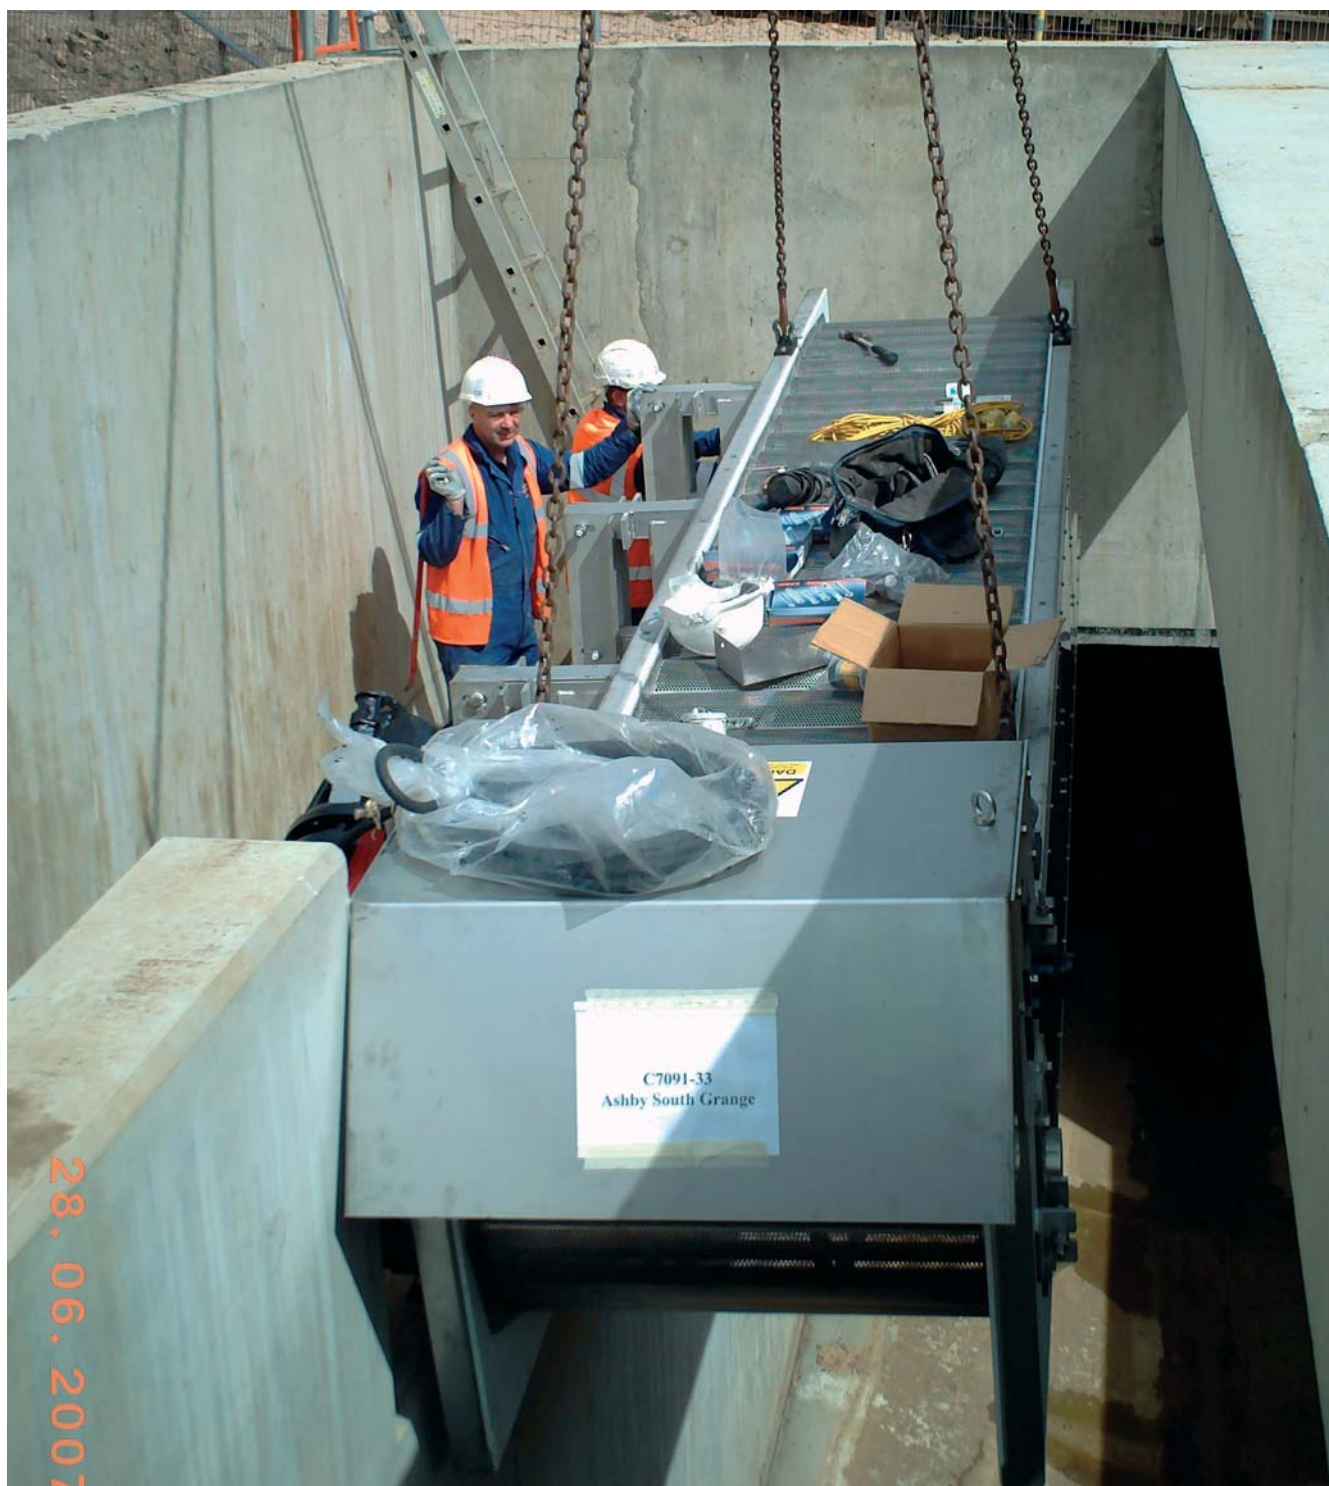
Screen installation at Ashby South Grange

This CSO is located in a public open space and the site was previously a Sewage Treatment Works before being abandoned in the late 1970s. The CSO had operational difficulties and the screen was prone to blinding, therefore resulting in unsatisfactory performance. As a result, the CSO was the cause of aesthetic problems at the nearby watercourse (Bottesford Beck) and a works identified to rectify the problem.

- * provision of 1300m³ of storage at Ashby South Grange;
- * construction of a new CSO chamber incorporating a mechanical screen;
- * increase flow to full treatment at Yaddletorpe Sewage Treatment Works; This required an additional final settlement tank to be constructed and would coincide with other planned works at this site.
